LER 1998-006
Davis-Besse Nuclear Power Station, Unit No. 1
Date of Occurrence - June 24, 1998

Davis-Besse Unit Number 1

Tornado Damage to Switchyard Causing Loss of Offsite Power

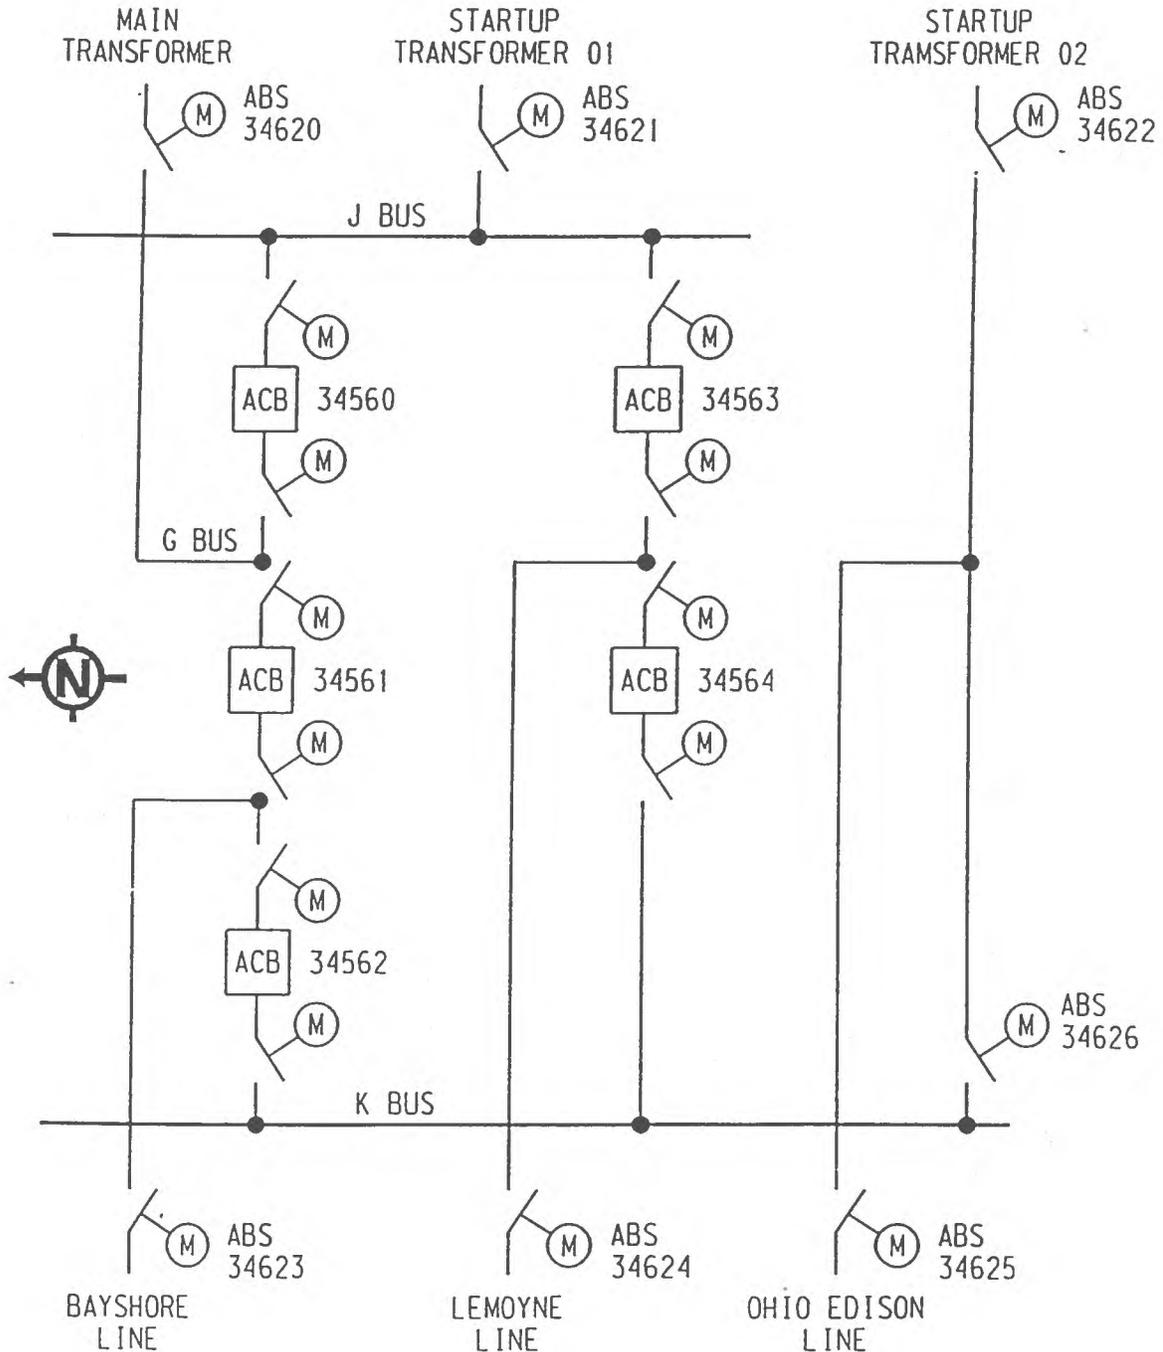
ATTACHMENT 2
345 KV SWITCHYARD ONE LINE

At 2230 hours, the initial switchyard [FK] damage report indicated that there was substantial damage, which included the following (Reference Attachment 2): ABS 34620 had one broken connector [EA-CON], ABS 34621 had two broken connectors, ABS 34622 had one broken connector and ABS 34623, 34624 and 34625 were also damaged. This damage resulted in the loss of all three offsite power sources: Bayshore, Lemoyne and Ohio Edison lines. At 2238 hours, the plant entered Technical Specification (TS) 3.8.1.1 Action d, to restore at least one of the inoperable offsite sources within 24 hours. At this time, the unit was in HOT STANDBY and both EDGs were supplying their essential loads.

The switchyard equipment and transformers were inspected for extent of visible damage, and protective relaying target indications were reviewed for possible indication of further damage. No damage was indicated and the transformers were electrically tested satisfactorily. The damaged Motor Operated Disconnects (MODs) [MOD] were disassembled, reworked and reassembled.
