Subject: **Docket No. 50-361**
Licensee Event Report No. 2008-006
San Onofre Nuclear Generating Station, Unit 2

Unit 2 LER No. 2008-006

4. TITLE
Loose connection bolting results in Inoperable Battery and TS violation

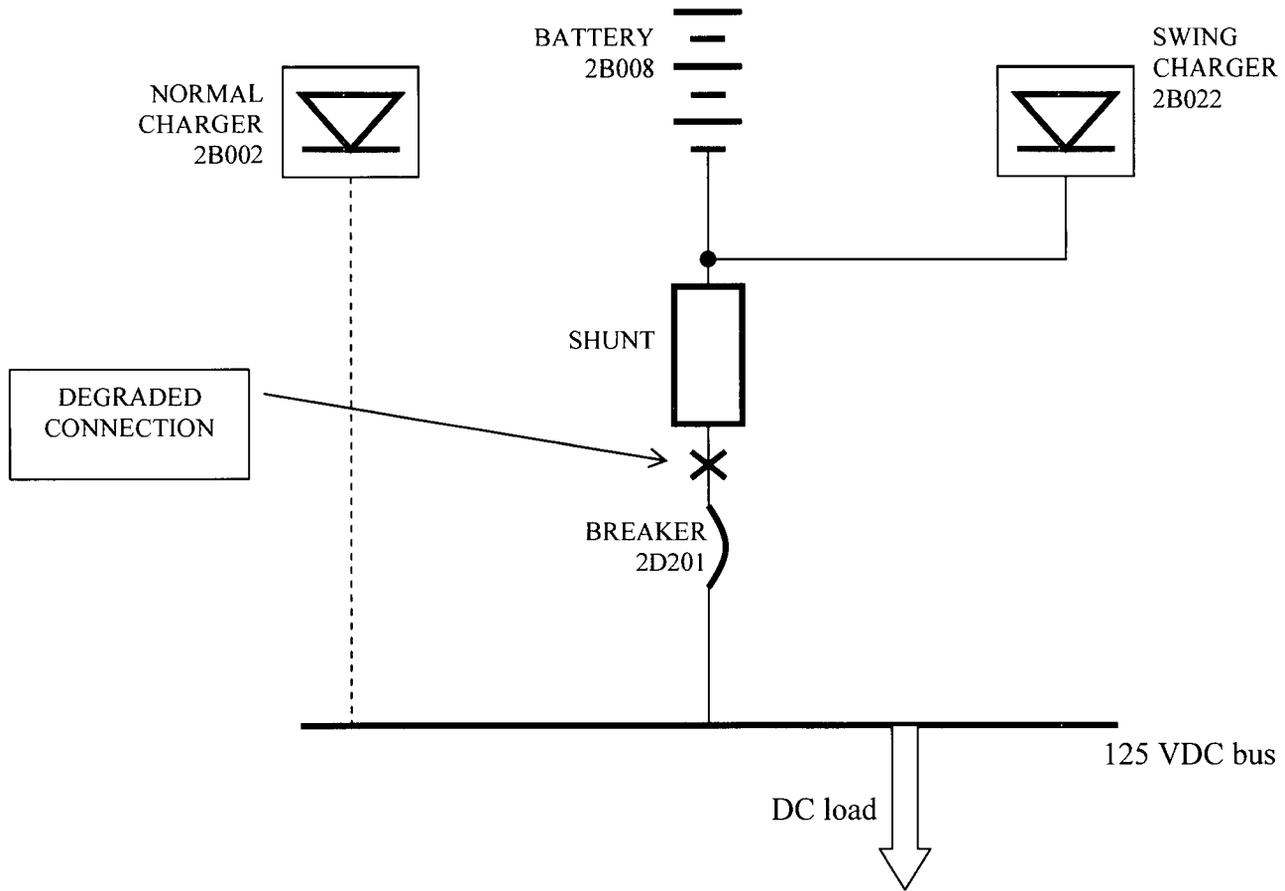
Figure: DC System Configuration

Technical Specification 3.8.4 requires Trains A, B, C and D electrical power subsystems to be operable in Modes 1 through 4. If one electrical subsystem is inoperable, Action A.1 requires restoration of the DC electrical power subsystem to operable status within 2 hours. If not completed within 2 hours, Action B requires Operators to place the plant in Mode 3 within 6 hours and Mode 5 within 36 hours. TS Surveillance Requirement 3.8.4.1 requires SCE to verify battery voltage is greater than or equal to 129 VDC once every 7 days. Technical Specification (TS) Surveillance Requirement (SR) 3.8.4.6 requires verification of each battery charger capability every 24 months. During this surveillance a swing charger is connected at the battery and supplies the DC bus through the same DC breaker. This allows isolation of the normal charger for testing (See attached figure).

On March 25, 2008 (Discovery Date), with Unit 2 at approximately 100 percent power, plant personnel began performance of the weekly surveillance (SR 3.8.4.1) of the Train B battery (2B008). The SR requires battery voltage to be greater than or equal to 129 VDC at the battery terminals. At about 0415 PDT, plant personnel discovered the battery voltage below the required value. Subsequently, while attempting to verify the low battery voltage reading, indications of a loose connection were observed on the bolt on the battery side of the breaker (2D201) that connects the battery to its DC bus (2D2) (See attached figure).

SCE subsequently determined that the loose electrical connection on breaker 2D201 most likely caused battery 2B008 to be inoperable for about 4 days prior to discovery (see the Safety Significance section below). Because this exceeds the Technical Specification allowed outage time (2 hours), SCE is reporting this occurrence in accordance with 10CFR50.73(a)(2)(i)(B).

SCE completed a root cause evaluation which concluded the 2D201 connection bolts were most likely not fully torqued on March 17, 2004 when Breaker 2D201 was last replaced. The bolts were not fully torqued due to an incomplete work plan and lack of effective second check of critical steps.

1. SCE torqued the connections identified as loose on March 25, 2008.
2. On July 15, 2008, SCE performed a ductor test on the connections which demonstrated an acceptable contact resistance of less than 10 micro-ohms.
3. SCE inspected the other three DC electrical trains for Unit 2 and all four trains for Unit 3 confirming the associated DC breakers did not have loose connection bolting.
4. SCE has added this event to Maintenance Training as Operating Experience.
5. SCE has coached the electricians responsible for installing breaker 2D201 in 2004 regarding expectations for job completion and documentation.
